REMEDIAL ACTION WORK PLAN

FORMER ROCKET JEWELRY BOX SITE
414 Gerard Avenue
Bronx, New York
Block 2350, Lot 1
NYSDEC BCP Site No. C203106

May 2018
Langan Project No. 170488401

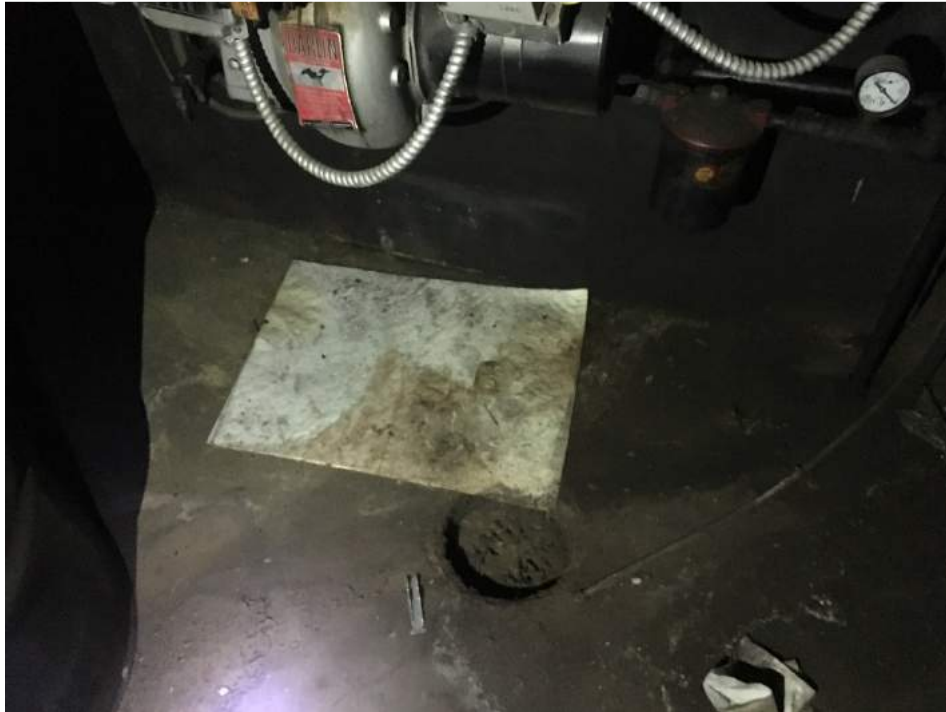
Photo 9: View of a stained absorbent pad and drain beneath the fuel oil connection pipe to the boiler

One 3,000-gallon AST was observed during the August 25, 2017 site reconnaissance. The 3,000-gallon AST was also identified in the NYSDEC PBS database. A fill port and vent pipe were observed on the exterior of the southern side of the building, and stained absorbent pads were observed in the boiler room near the fuel oil connection pipe. One unlabeled, 55-gallon drum containing an oily liquid was also observed in the boiler room.

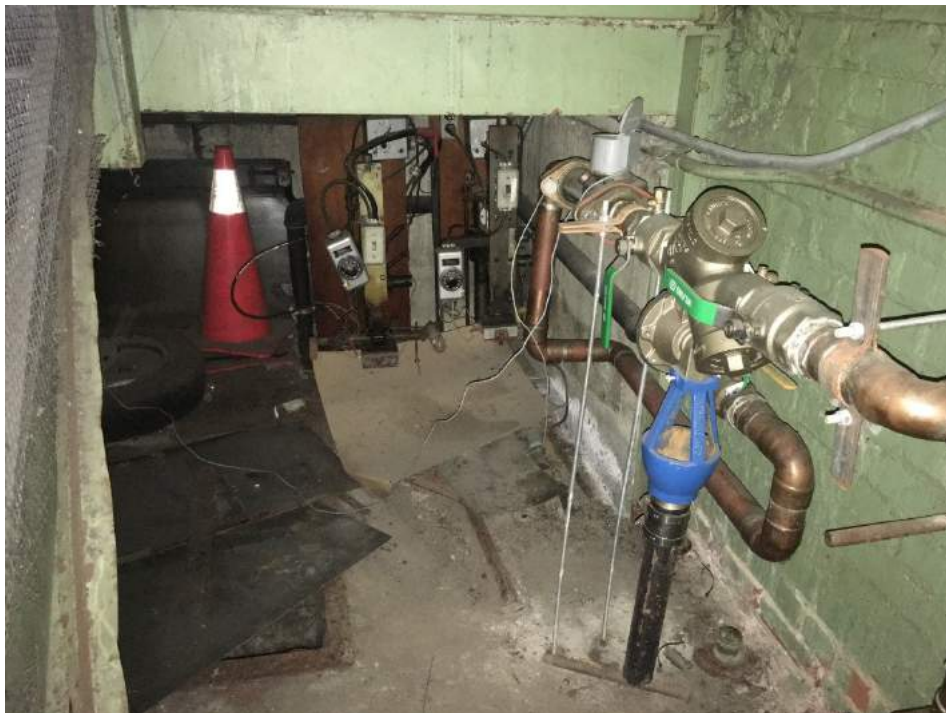
Photo 10: View beneath the staircase leading from the entrance off East 144th Street
