REMEDIAL INVESTIGATION WORKPLAN
180 East 132nd Street
BLOCK 2260, LOT 180
BRONX, NEW YORK
BCP C203118

File No. 12.0076605.10
October 2019

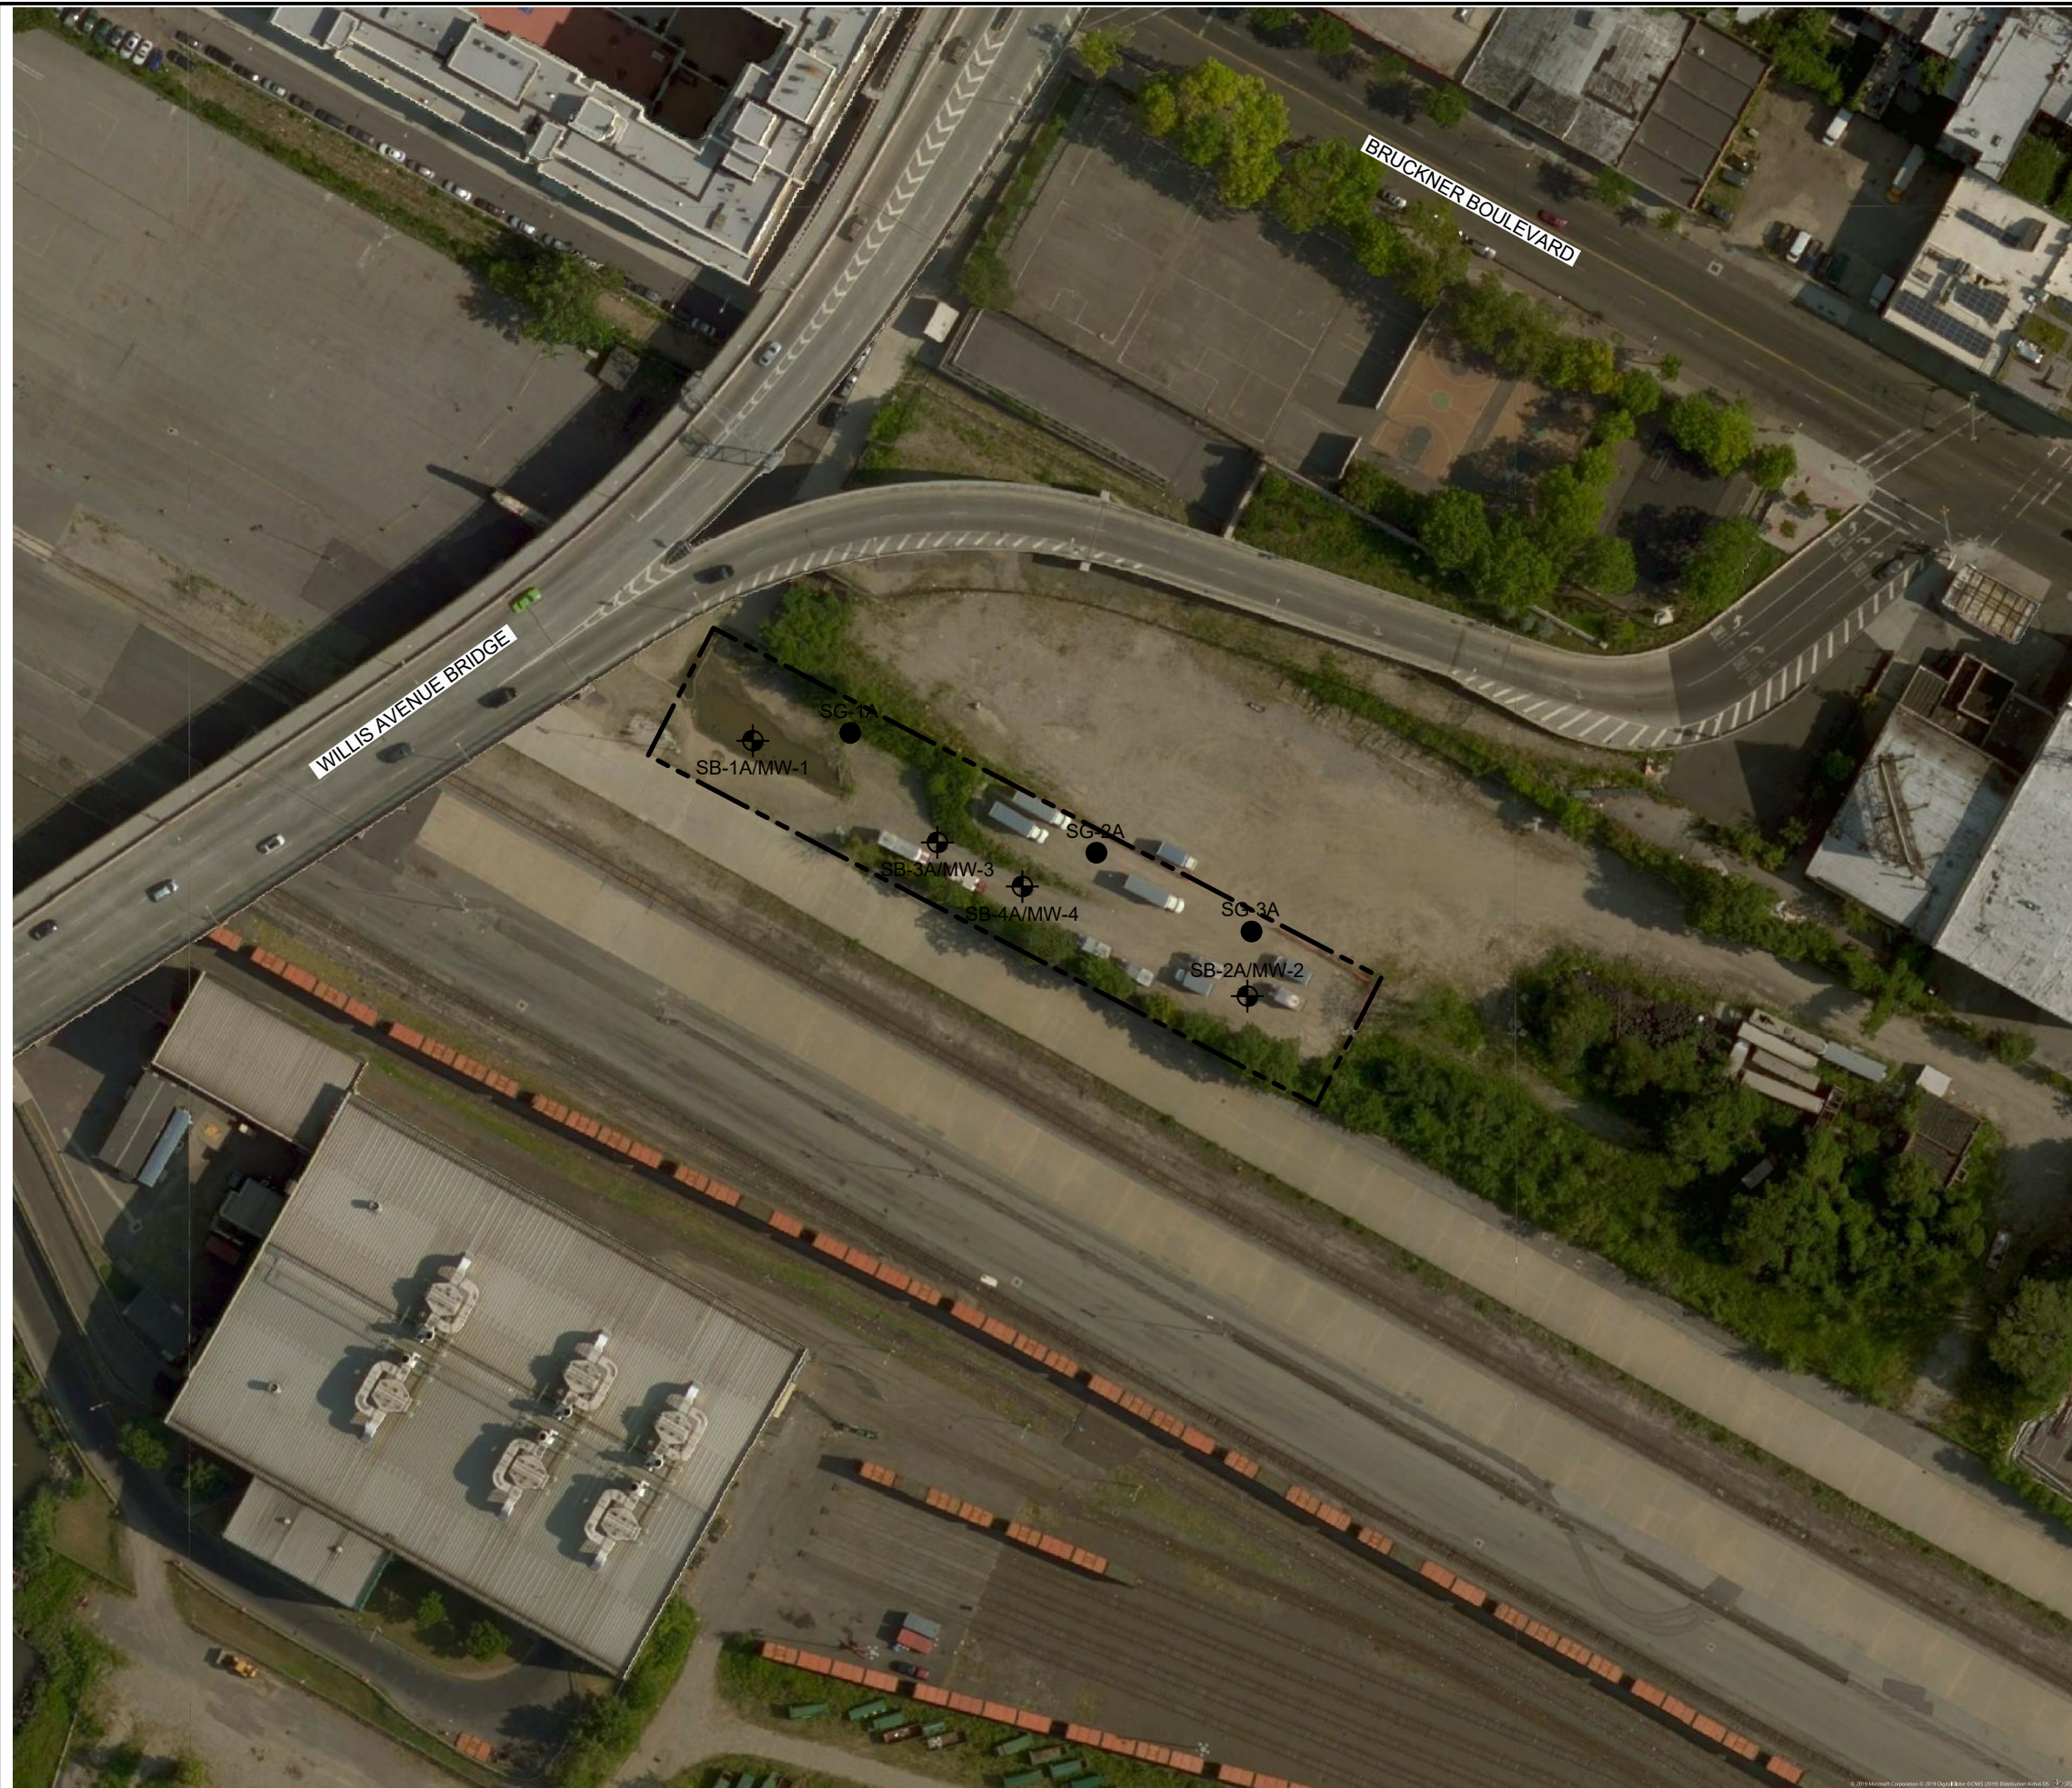
SITE PLAN

Adjoining properties are generally commercial. To the north is NYSDOT property, currently vacant and overgrown. This property extends to the east of the Site. North of the NYSDOT property is the Pulaski Park. South of the property are railroads owned by Amtrak, and south of this property is the Bronx Waste Management Center. West of the Site is the Harlem River Terminal Station, which is now a historical landmark and is not currently used. Other vicinity properties not adjoining are generally residential and commercial. There are no schools, hospitals, or day care centers within a 250 to 500-foot radius around the Site. **Figure 2** shows the surrounding land usage.

- SITE BOUNDARY
- ⊕ PROPOSED MONITORING WELL AND SOIL BORING
- PROPOSED SOIL GAS SAMPLE POINT

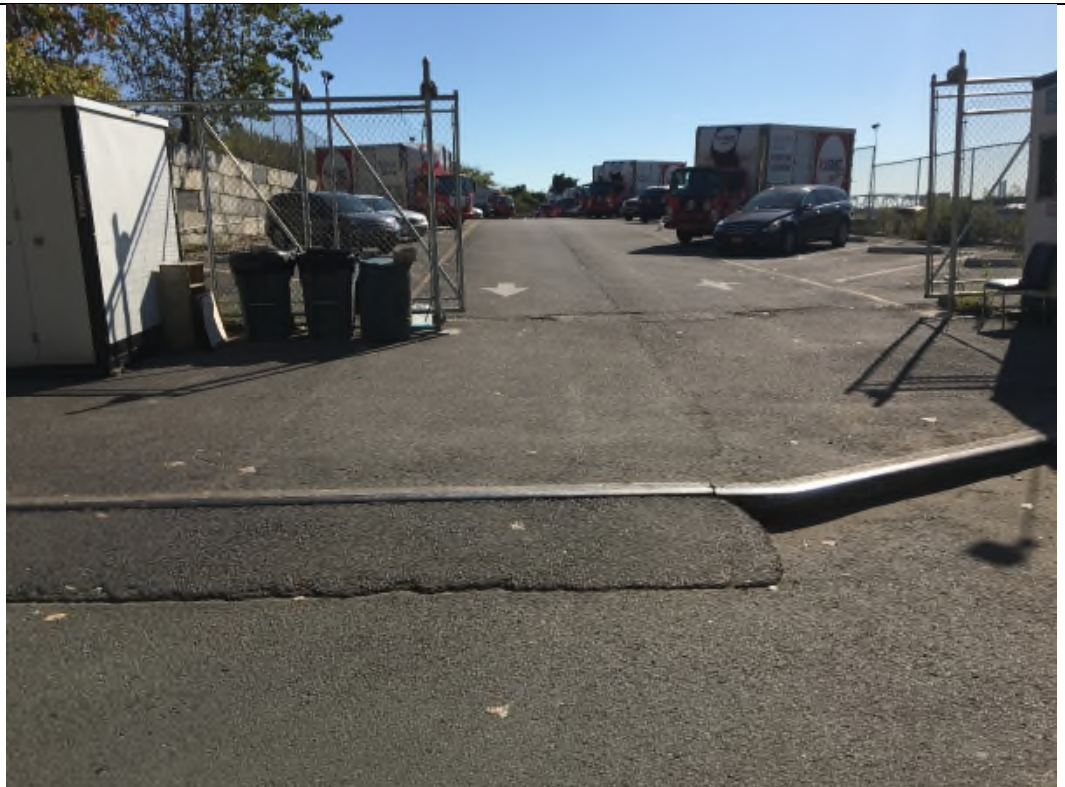
Photo No.: 2	Date: 10/18/2017
Direction Photo Taken: Looking east	
Photographer: CM	
Description: Closer view of trucks on site.

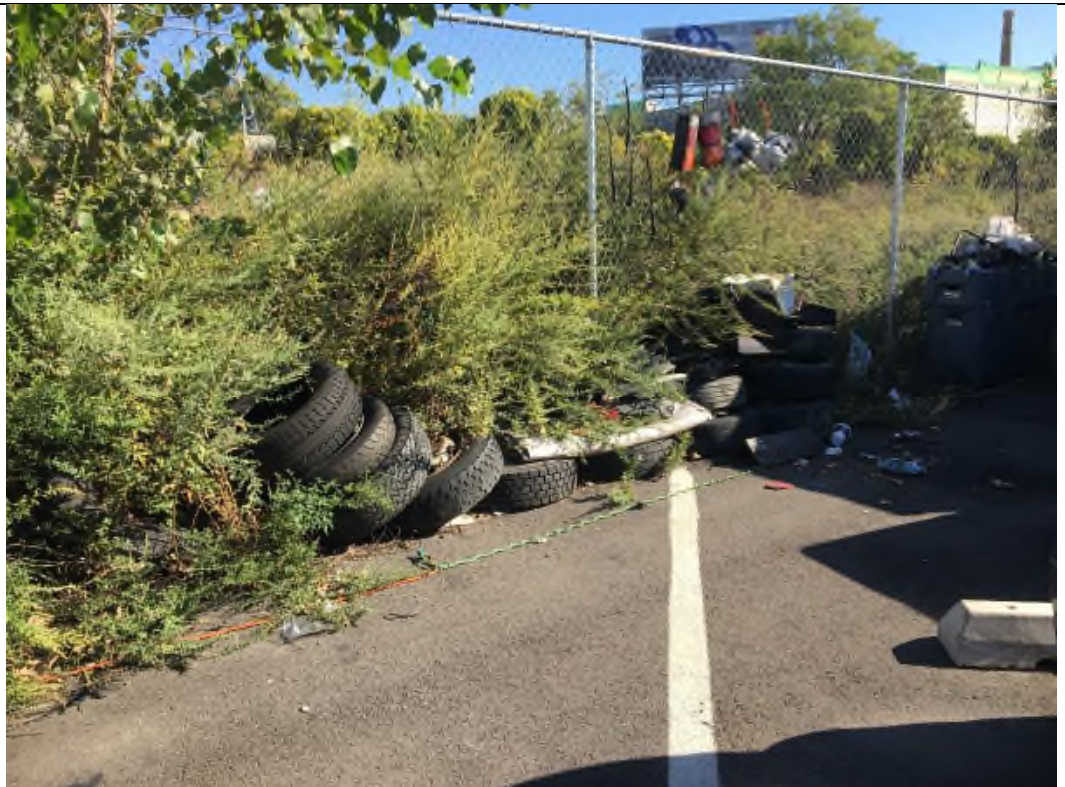
Description:
Tires and additional garbage on site.

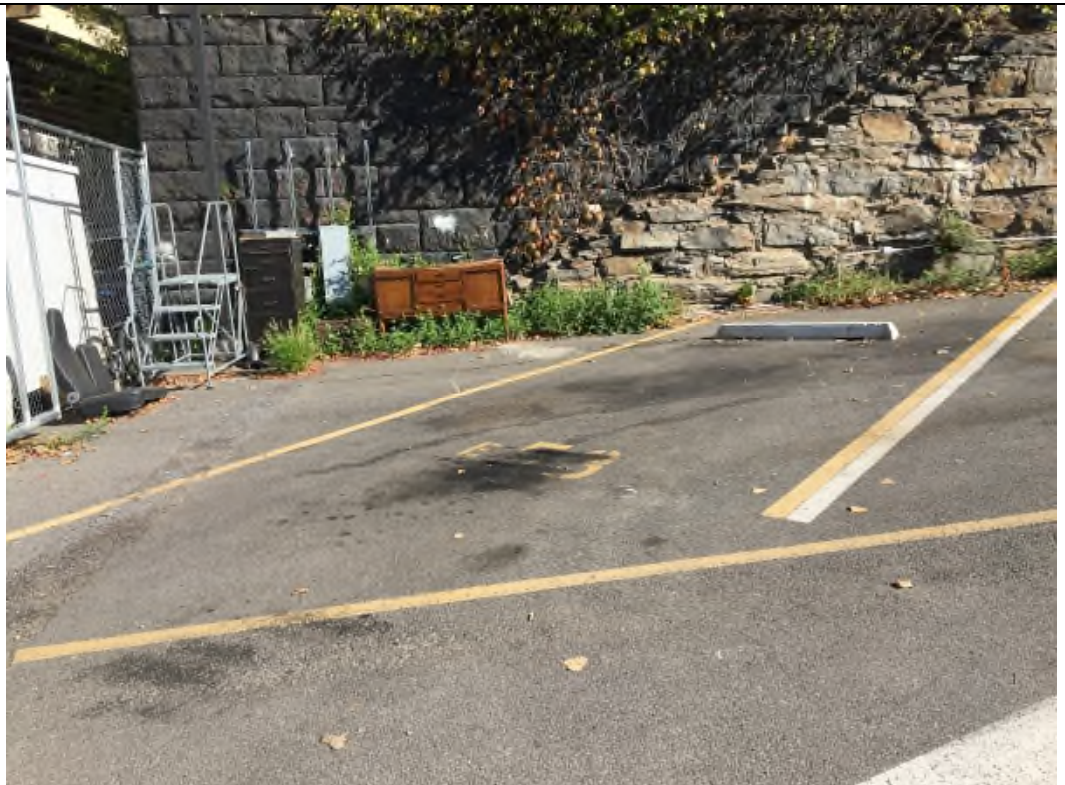
Description:
Staining on asphalt from parked vans and cars.

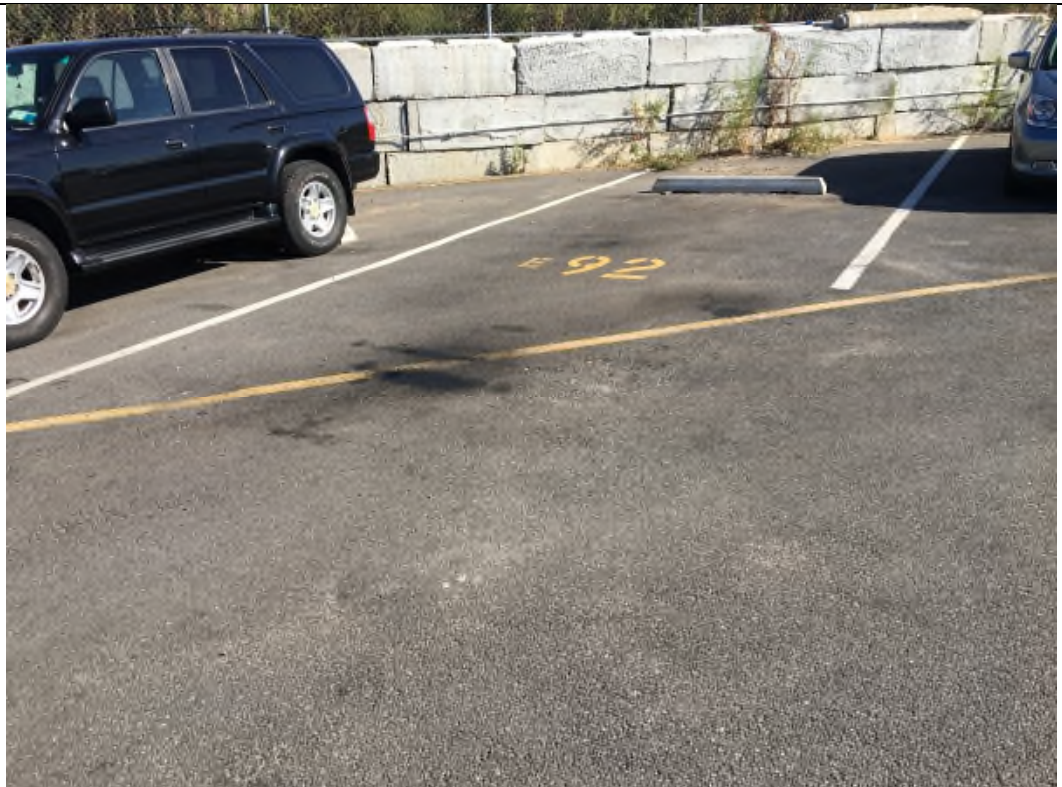
Photo No.: 7	Date: 10/18/2017
Direction Photo Taken: Looking north	
Photographer: CM	
Description: Staining on asphalt from parked vans and cars.

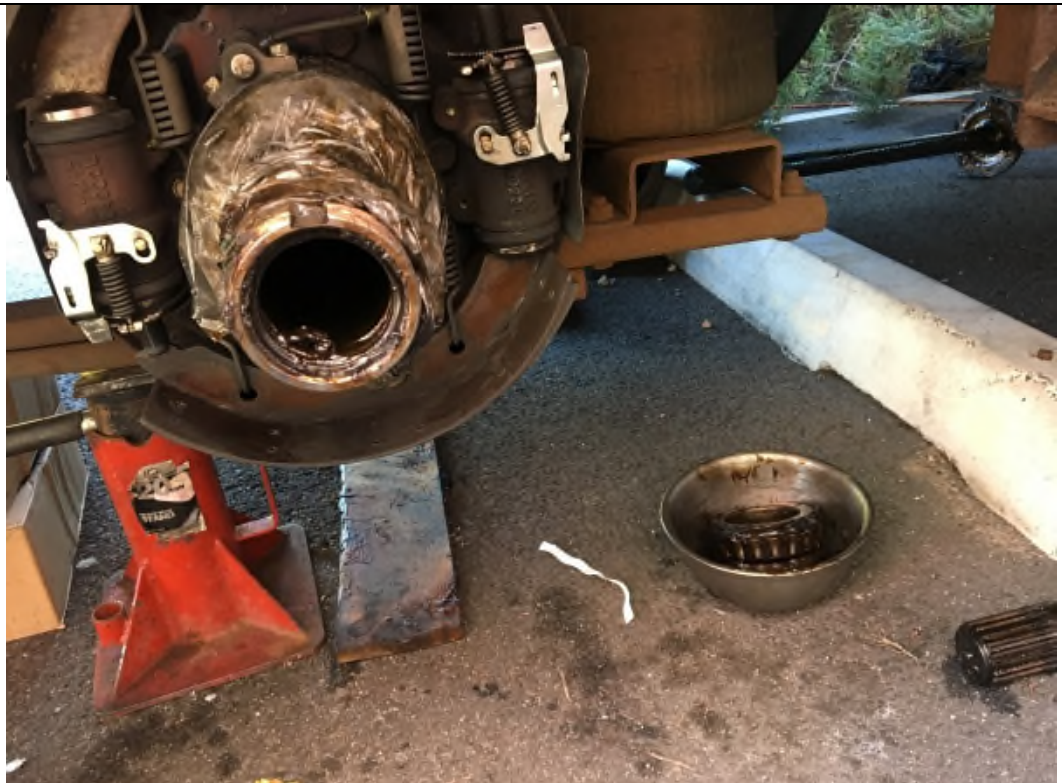
Photo No.: 8	Date: 10/18/2017
Direction Photo Taken: Looking north	
Photographer: CM	
Description: Grease container under one of the parked vans.

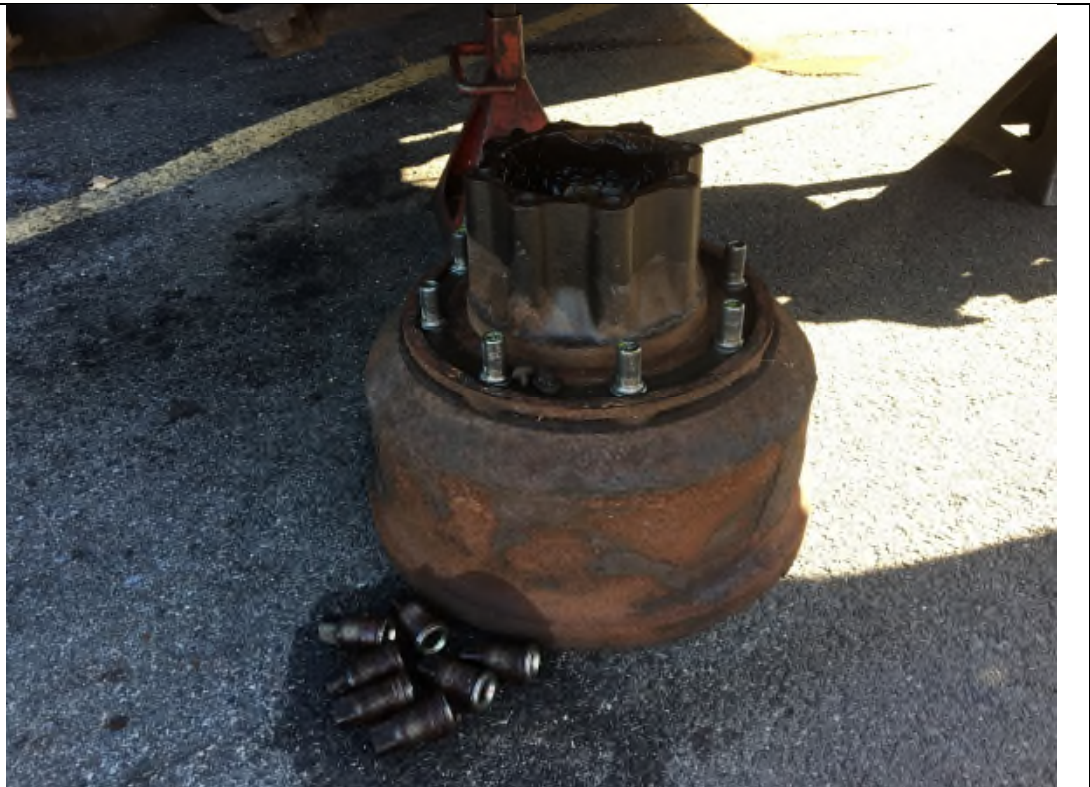
Photo No.: 9	Date: 10/18/2017
Direction Photo Taken: Looking north	
Photographer: CM	
Description: Grease container under parked van.

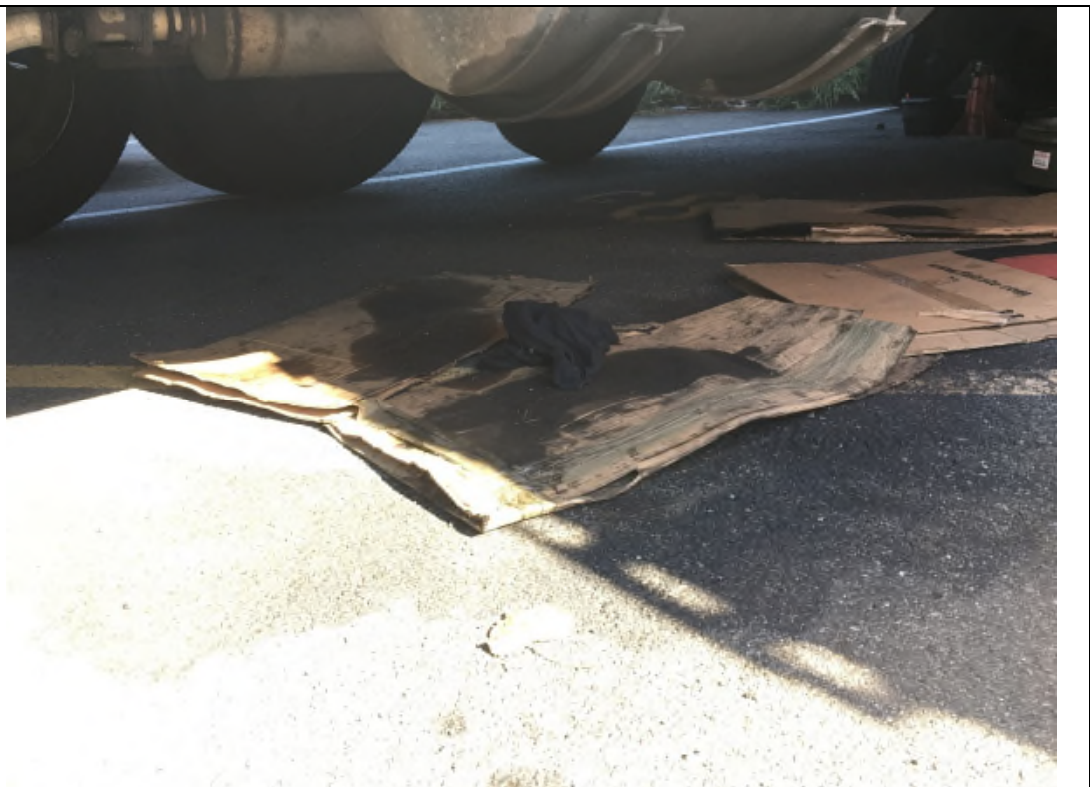
Photo No.: 10	Date: 10/18/2017
Direction Photo Taken: Looking north	
Photographer: CM	
Description: Greasy cardboard and asphalt under one of the parked vans.

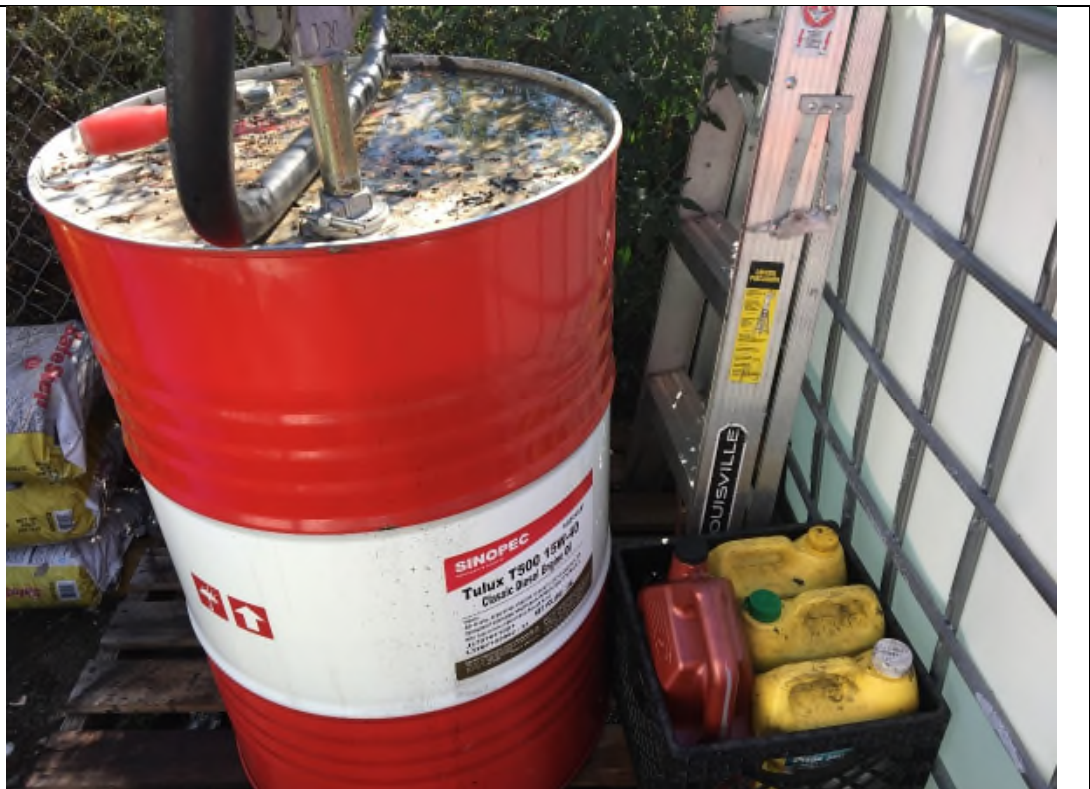
Photo No.: 11	Date: 10/18/2017
Direction Photo Taken: Looking east	
Photographer: CM	
Description: Diesel drum and gasoline containers.

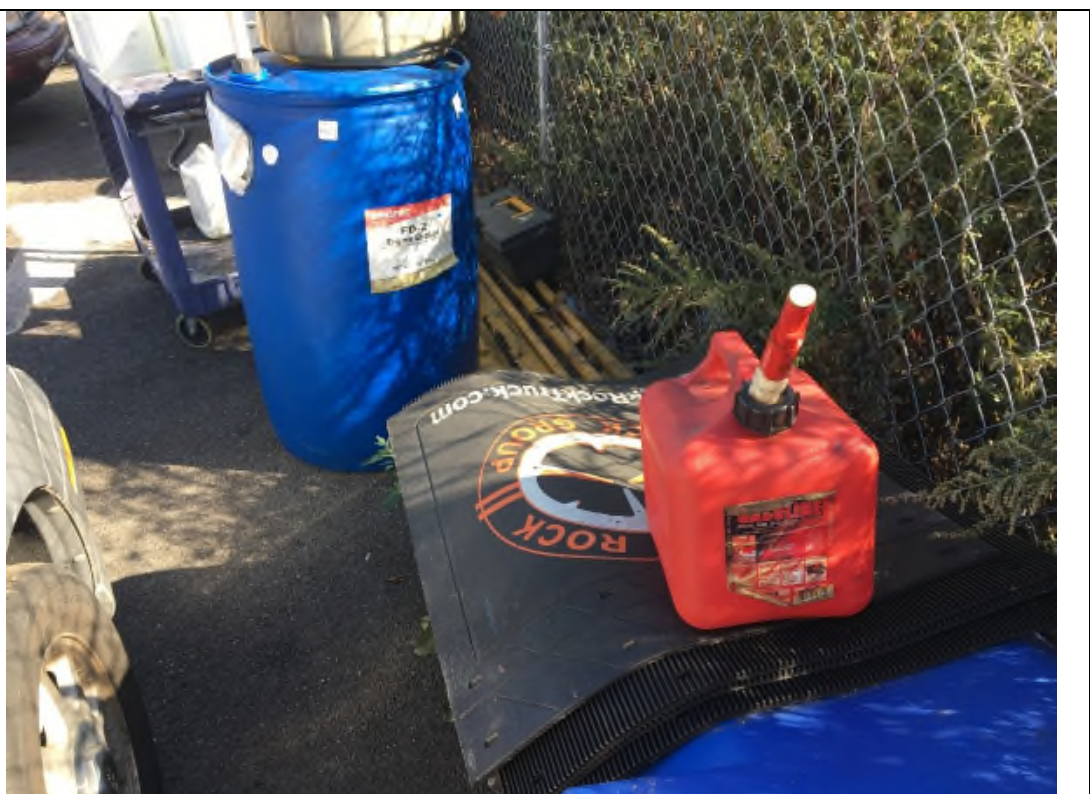
Photo No.: 12	Date: 10/18/2017
Direction Photo Taken: Looking northeast	
Photographer: CM	
Description: Drum filled with engine coolant and gasoline container.

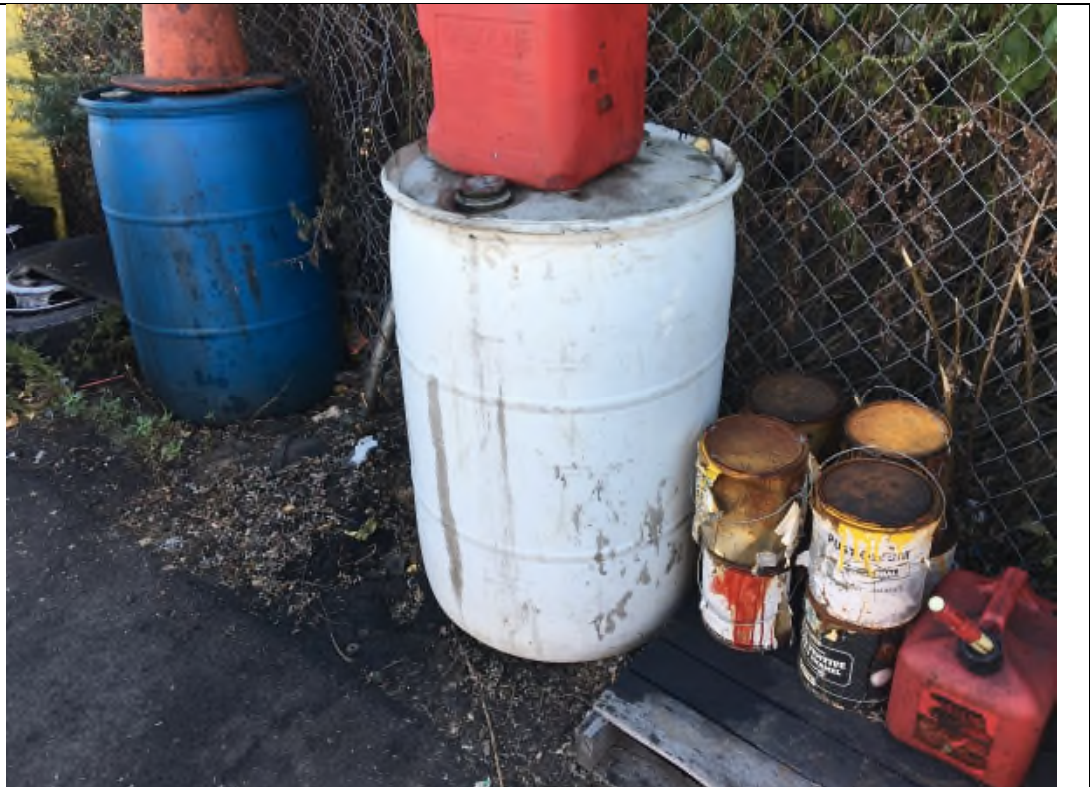
Photo No.: 13	Date: 10/18/2017
Direction Photo Taken: Looking east	
Photographer: CM	
Description: Drums, paint cans, and gasoline containers.

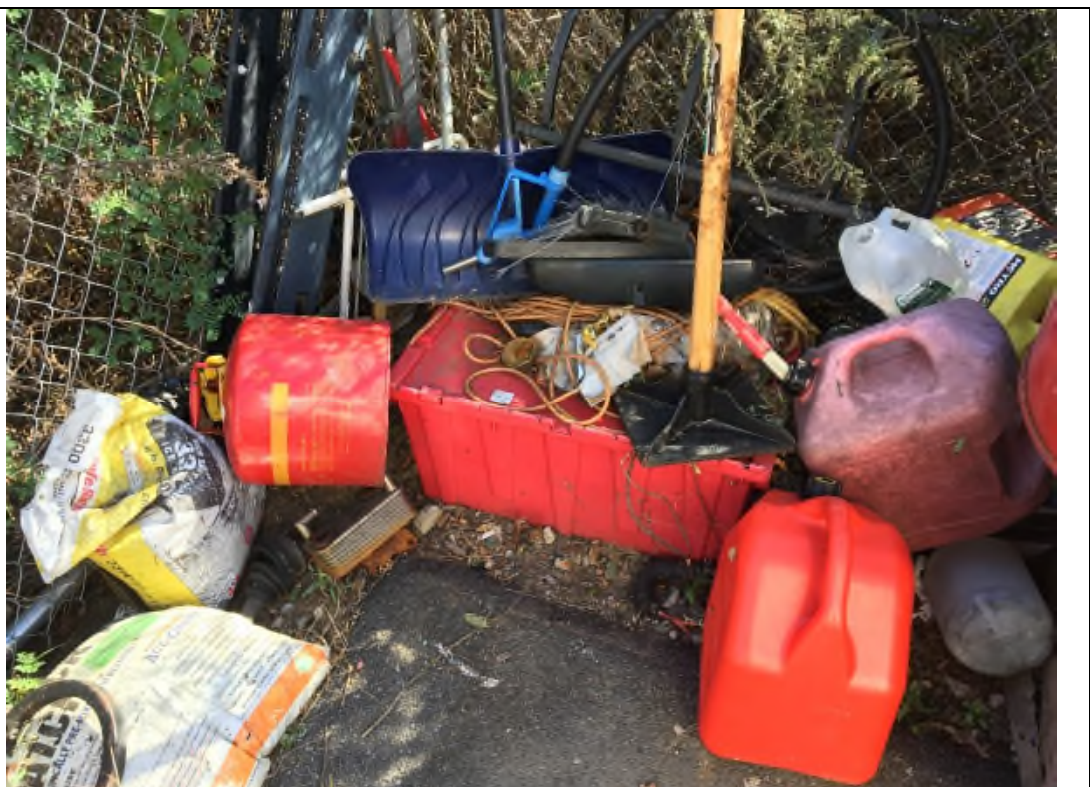
Photo No.: 14	Date: 10/18/2017
Direction Photo Taken: Looking northeast	
Photographer: CM	
Description: Gasoline cans, rock salt bags, and additional items in northeast corner of property.

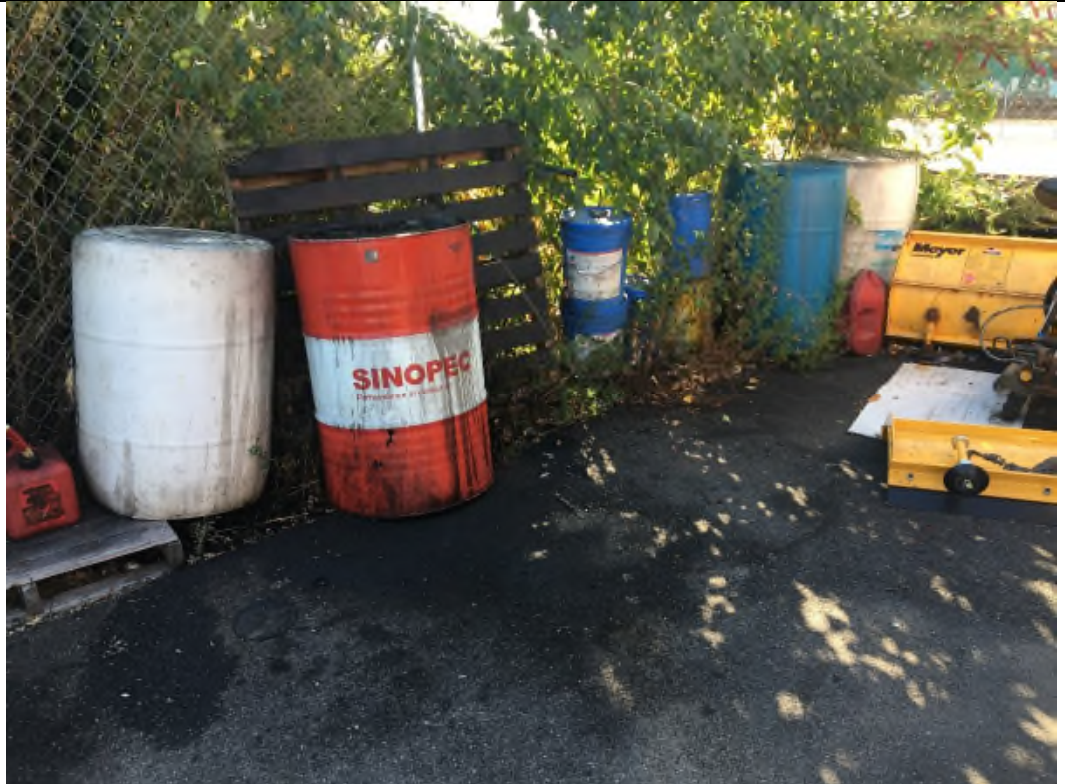
Photo No.: 15	Date: 10/18/2017
Direction Photo Taken: Looking east	
Photographer: CM	
Description: Grease drum and associated grease staining on asphalt.

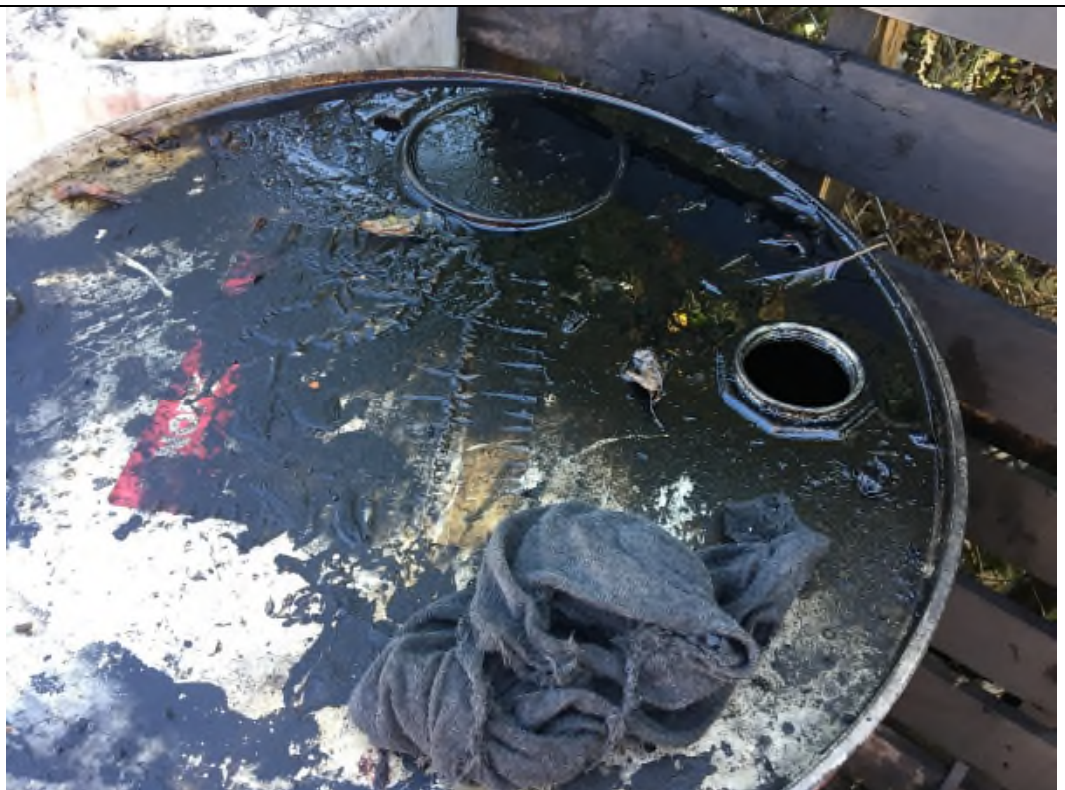
Photo No.: 16	Date: 10/18/2017
Direction Photo Taken: Looking east	
Photographer: CM	
Description: Grease on top of drum.

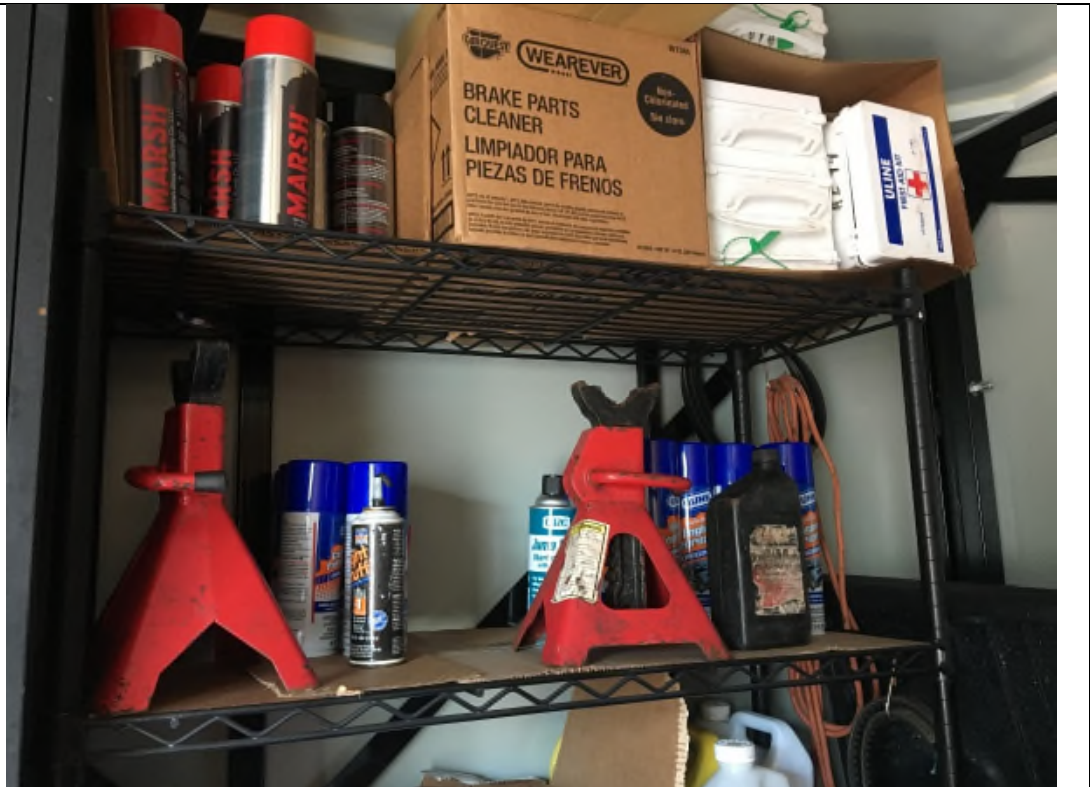
Photo No.: 17	Date: 10/18/2017
Direction Photo Taken: Looking northeast	
Photographer: CM	
Description: Degreasers, spray paints, cleaners in maintenance shed.

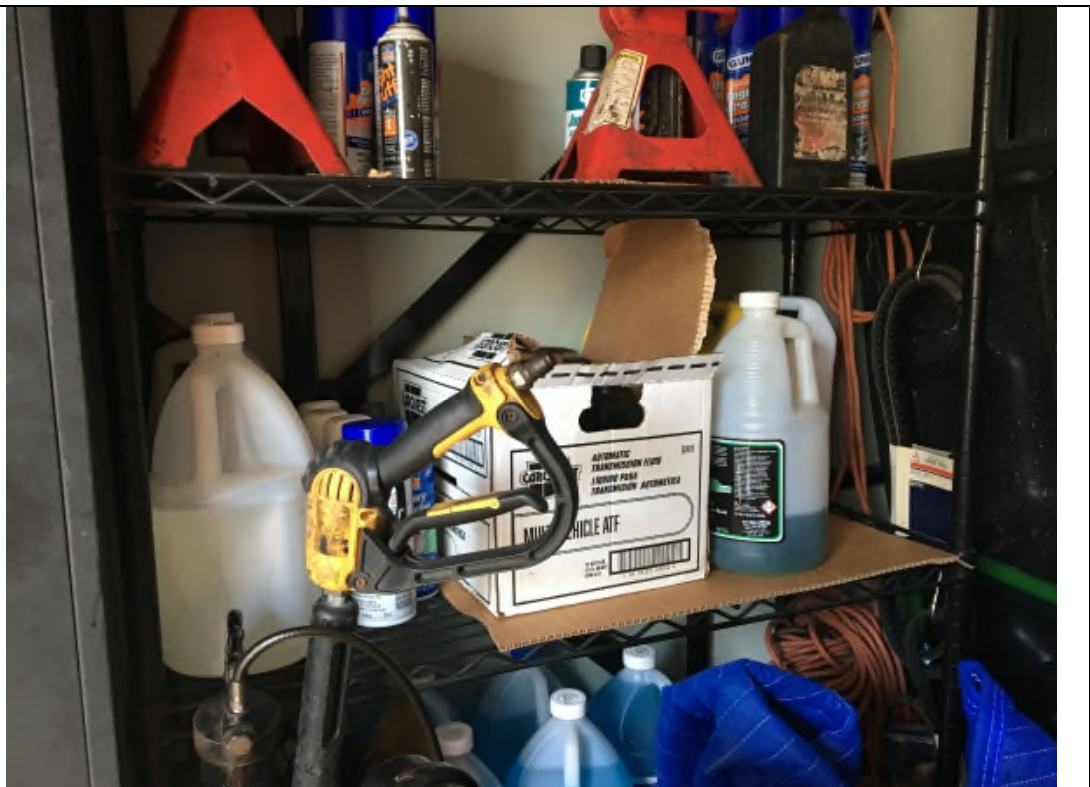
Photo No.: 18	Date: 10/18/2017
Direction Photo Taken: Looking northeast	
Photographer: CM	
Description: Degreasers, spray paints, cleaners in maintenance shed.

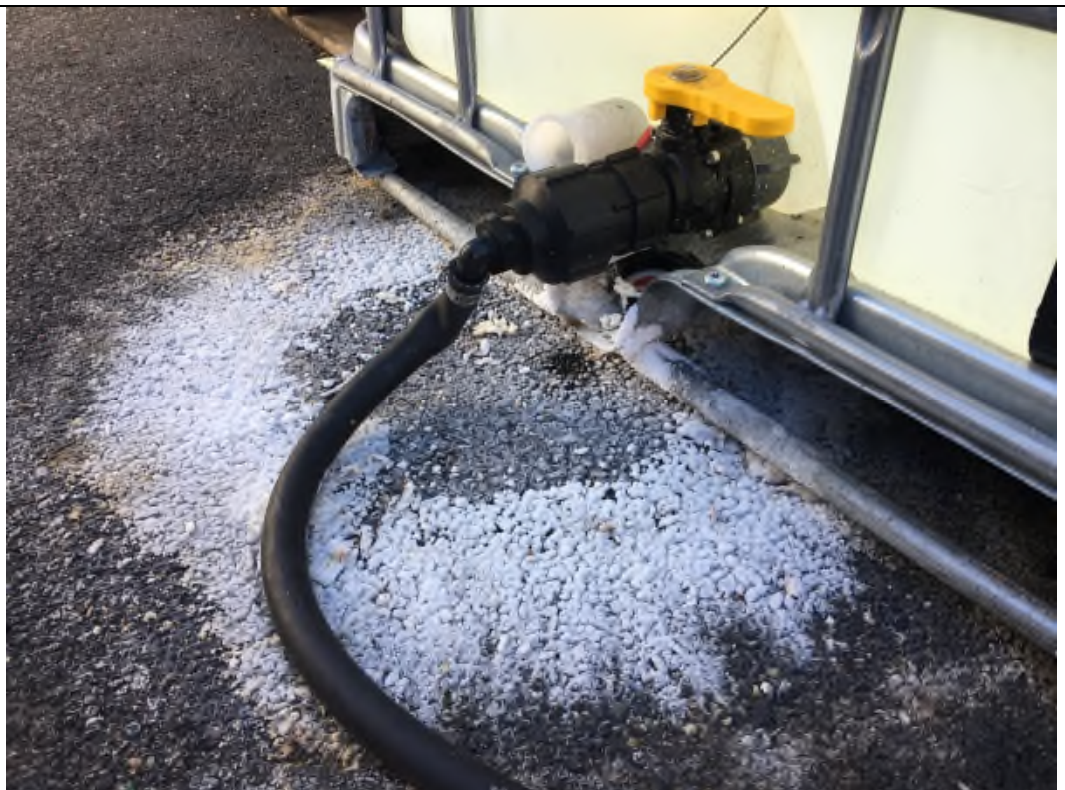
Photo No.: 20	Date: 10/18/2017
Direction Photo Taken: Looking northeast	
Photographer: CM	
Description: Crystallization of urea solution at base of container.

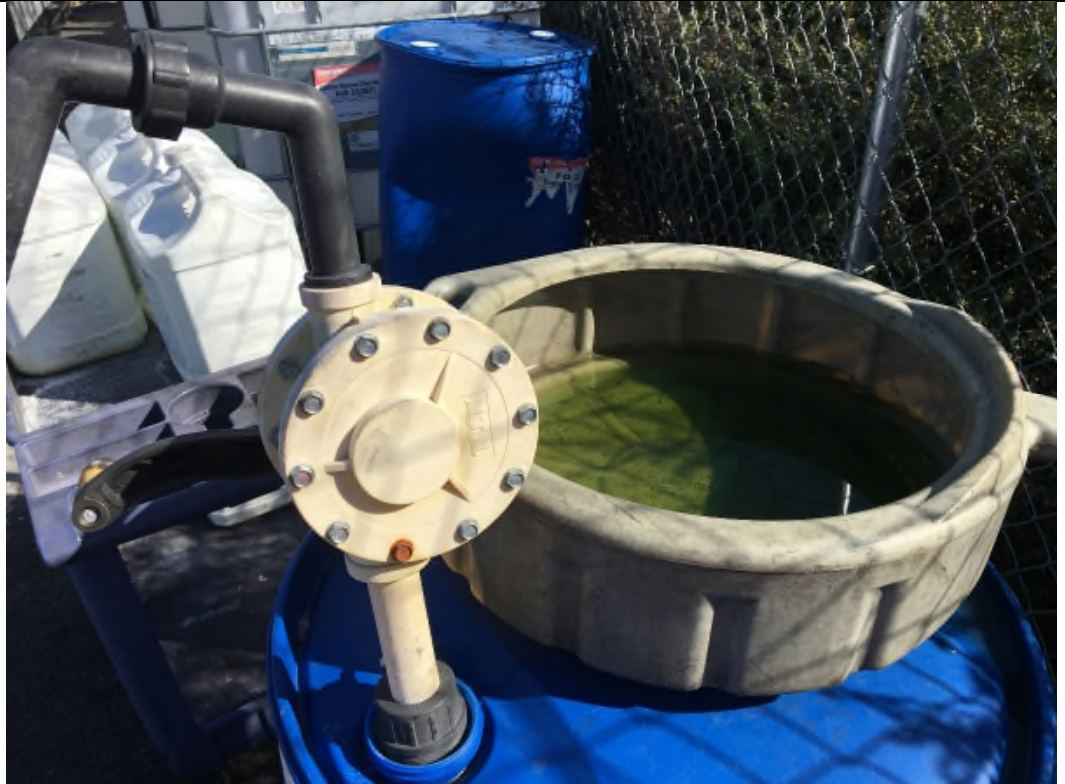
Photo No.: 21	Date: 10/18/2017
Direction Photo Taken: Looking northeast	
Photographer: CM	
Description: Open container with green fluid, possibly antifreeze.
